Fires Involving Air Conditioning Fan Coil Units (2008 – 2014)

The SCDF Fire Analysis Report series aim to make sense of similar fires seen over the years. Each report will provide details on the trends, patterns and other findings from the analysis of a specific type of fire or fire-related topic. Relevant examples of actual fire incidents will also be presented. In addition, fire safety tips or references to sources of information relating to fire prevention will be provided.

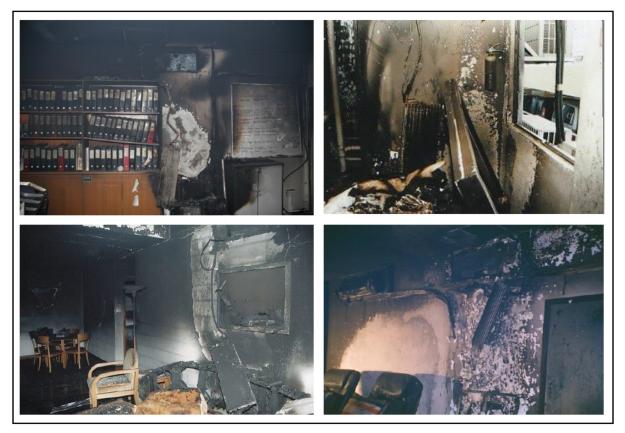
There were significantly more fires involving the CU and the FCU. From 2008 - 2014, fires involving the CU accounted for 42.6% of all A/C system fires. CU fires were observed to be largely localised (see **Figure 6**) with no potential of extensive fire spread as the CUs are located outdoors, with no other combustibles nearby. FCU fires, on the other hand, account for 44.2% of all A/C system fires from 2008 - 2014. As illustrated in **Figure 7**, FCU fires can possibly result in substantial property damage.

Figure 7. Fires originating from the FCU

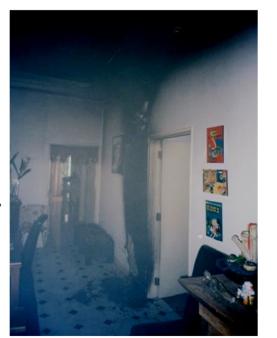
From the fire investigation photographs of the various FCU fires from 2008 - 2014, 1 possible manner in which some FCU fires develop became evident. As shown in Figure 8, fire can start at 1 end where the motor and circuitries are located. From there, the fire will spread laterally. At some point, the FCU dislodges and leaves the mounting plate on the wall. It should be noted that from the point of ignition, drop down² is possible and if there are combustibles beneath, the drop down can possibly start secondary fires below the

Figure 8. Development of FCU Fires

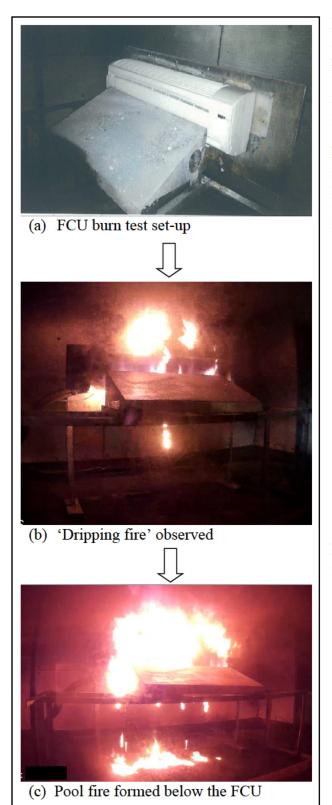
Figure 9. FCU burn test set-up and the drop down effects observed

Burn tests conducted on FCUs (see Figure 9) show that the plastic cover of the FCU would melt and result in 'dripping fires'. The pool fire formed below the FCU is evidently a competent ignition source that can start a secondary fire involving combustible placed under the FCU.

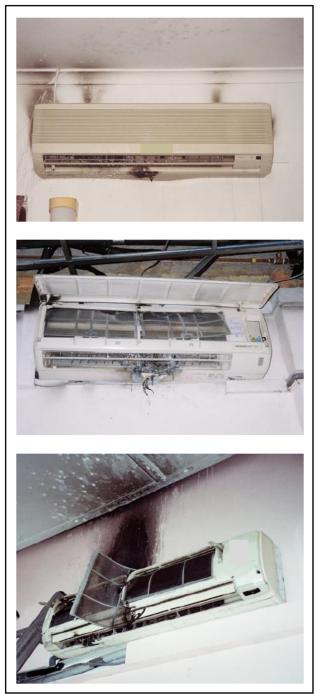
Another location where FCU fires can start was observed to be behind the louvers, near the midsection of the FCU as shown in **Figure 11**. Away from the motor and circuitries, the only possible ignition source for such fires is from the electrical cables that run across the length of the FCU. Such a fire will be examined in greater detail in 1 of the subsequent sections (Be Warned!) of this report.

Figure 11. Fires originating from the mid-section of the FCU

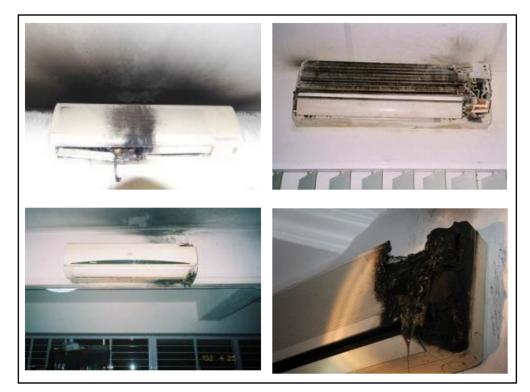
As stated in the NFPA921: Guide for Fire and Explosion Investigations, for ignition to be from an electrical source, the electrical wiring, equipment or component must have been energised [5]. Unless the isolator near the CU is switched off, current will still be flowing in the wirings to the FCU. While this current that is going to the FCU on standby mode is low, at 0.01A for some brands, it should be noted that ignition is still possible. As shown in **Figure 12**, 26.4% of all FCU fires from 2008 – 2014 were involving FCUs that were not operating but on standby mode. **Figure 13** shows 4 localised fires involving the FCU on standby mode. A clear sign that these FCUs were on standby mode is that the louvers were all closed.

Figure 13. Localised fires involving FCUs which were on standby mode

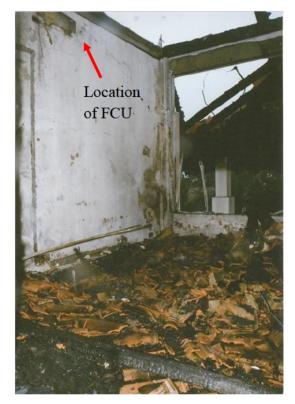
A 10-year-old girl was sleeping on her bed at the upper floor of a 2-storey house when she saw the FCU above her bed catching fire. She got out just before the FCU fell onto her bed and ran to inform her mother next door. When she returned with her mother, the bed already was well alight and they evacuated from the house with the rest of the family members. As a result of the fire, the entire level 2, including the roof, was damaged (see **Figure 14** and **15**).

Figure 14. The FCU caught fire and the drop down ignited the bed directly beneath

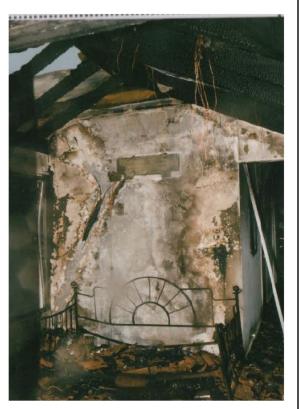
Figure 15. Another room on level 2 that was gutted by the fire

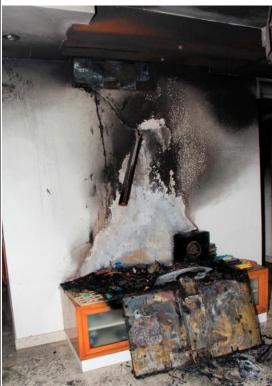
A project manager was holding a meeting in the same building when he received a call from his colleague informing him of black smoke bellowing from an apartment on 1 of the higher floors. He and 3 of his colleagues then rushed up to the affected apartment to investigate and on seeing the fire, they used a hose reel to extinguish it. Drop down from the FCU fire ignited the TV and other items on the TV console (see **Figure 18**). The apartment sustained heat and smoke damage as a result of the ceiling jet³ and ceiling layer⁴ from the FCU fire (see **Figure 19**).

Figure 19. The apartment sustained heat and smoke damage as a result of the ceiling plume from the FCU fire

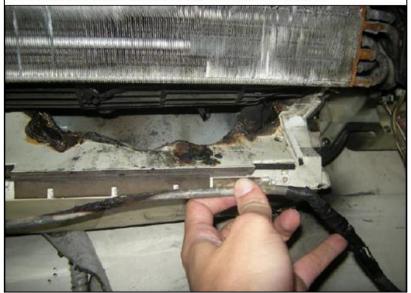
Figure 22 shows a localised FCU fire. A close examination of the motor and circuitries (see Figure 23 and Figure 24) show that both were completely unaffected and hence, ruled out as the cause of fire. The burnt area on the FCU is captured in Figure 25 with the electrical cable that was running across the FCU being held in place.

The burnt section on the left side of the cable was damaged as a result of the fire as the bulk of the insulation is still intact. Had this section been the cause of fire, the insulation would have been consumed by the fire inside out.

Figure 25. The burnt area on the FCU with the electrical cable that was running across

The burnt section on the right is an intermediate connection achieved by twisting wires together and insulating them with electrical tape. A zoomed-in image of this intermediate connection can be found in **Figure 26**. From **Figure 26**, one would be able to see mass loss to the electrical tape, with the internal wiring exposed. All the above investigation findings are consistent with the ignition source of the fire to have come about from this point on the intermediate connection.

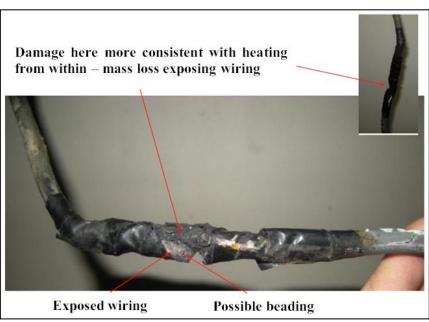
Figure 26. A zoomed-in image of the intermediate connection

Described as 'a flagrant violation of both regulation [16] and good sense' in the Ignition Handbook [17], electrical splices achieved by twisting wires together and insulating them with electrical tape are not allowed in the United States as they have been found to be the cause of many fires in the earlier days. The use of such splices in FCUs may greatly heighten fire risk as water from condensation can come into the picture.
