Fires Involving Air Conditioning Fan Coil Units (2008 – 2014)

The SCDF Fire Analysis Report series aim to make sense of similar fires seen over the years. Each report will provide details on the trends, patterns and other findings from the analysis of a specific type of fire or fire-related topic. Relevant examples of actual fire incidents will also be presented. In addition, fire safety tips or references to sources of information relating to fire prevention will be provided.

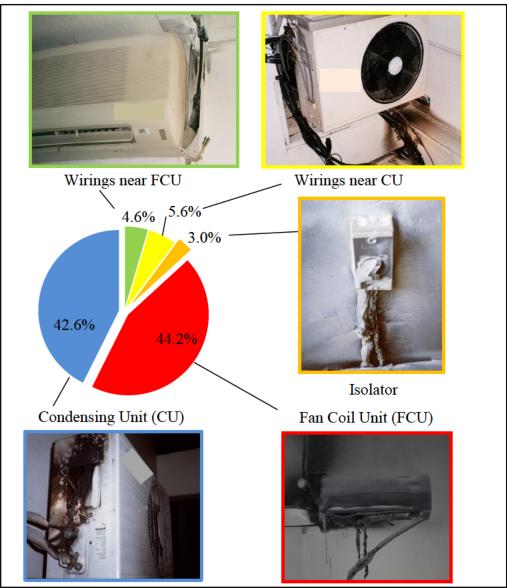
Various parts of the A/C system can catch fire as shown in **Figure 5**. For all the A/C system fires registered during the 7-year period from 2008 - 2014, 5.6% were noted to involve wirings near the CU while 4.6% involved wirings near the FCU. Fires involving the isolator accounted for 3.0%.

Figure 5. Breakdown of A/C Fires (2008 – 2014)

The detailed breakdown of the specific number of cases can be found in **Table 1**. Evident from the photographs in both **Figure 5** and **Table 1**, all the wirings and isolator fires were localised with most of them burning themselves out without any human intervention.
